FINAL REPORT

Spring Mission: February 27, 2009 – April 10, 2009

Luigi De Cesaris & Alberto Sucato, Restorers

“Conservation and Documentation of the Wall Paintings at the Red Monastery, Sohag”

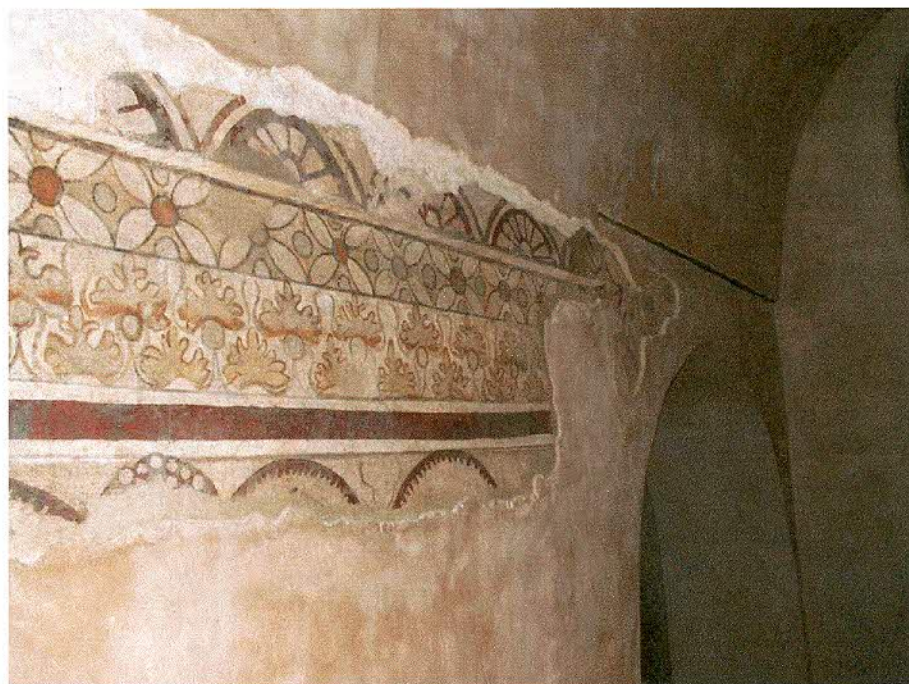
Fig. 1

The conservation campaign conducted in the Monastery of St Bishoi (Red Monastery) at Sohag during the spring of 2009 involved various parts of the building: the facade (F); the first tier to the left and right of the arch giving access to the triconch¹; the prothesis (NEC) and adjacent north corridor (NEB) and the counterparts to these areas on the south side of the monument, namely the diaconicon and the south corridor (Fig. 1) (SEC-SEB).

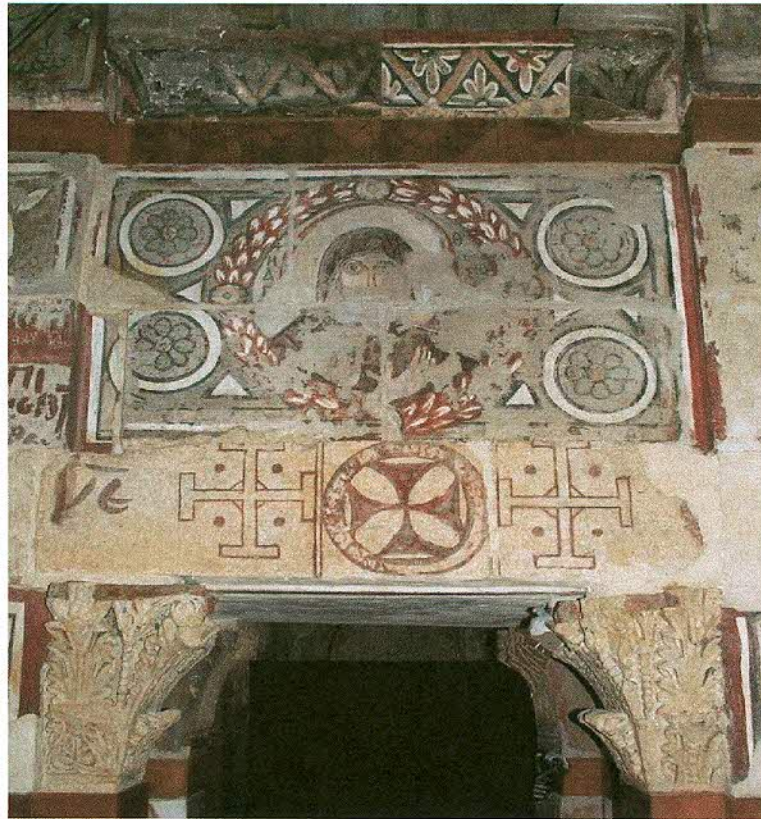
Fig. 2

As a result of the work, particularly on the right side of the facade (Fig. 2), a substantial percentage of the painted surface has been restored, enabling us to ensure the esthetic unity of restoration over such an enormous area.

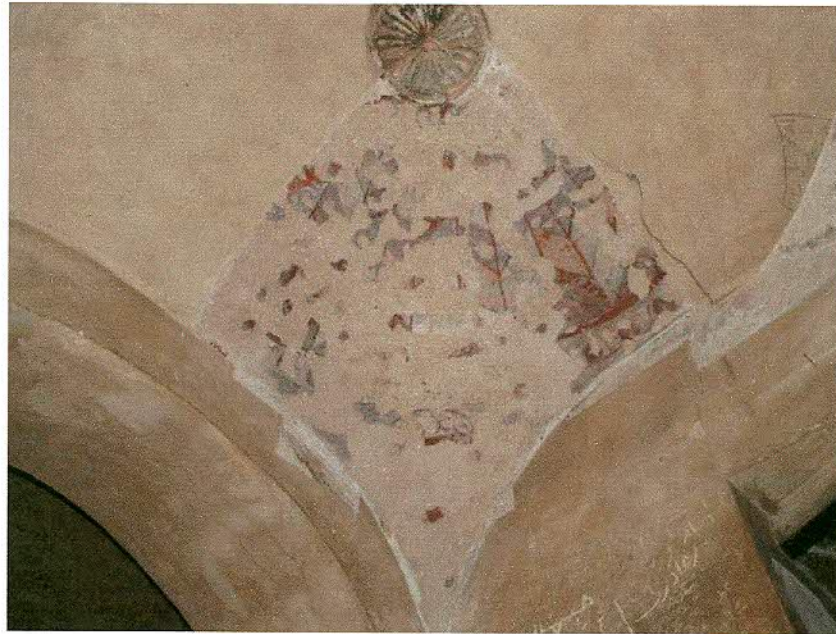
Fig. 3

In the diaconicon (SEC) the test area where the plaster has been removed from the vault has been enlarged to cover a quarter of the entire surface (Fig. 3). The work has enabled us to recover the underlying geometric decoration although it is very patchy.

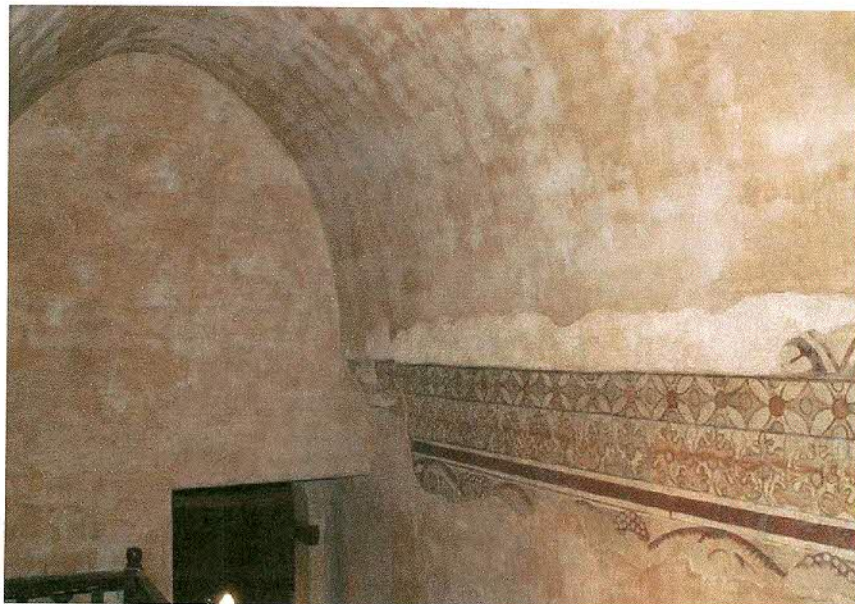
Fig. 4

In the adjacent corridor (SEB), all the late antique surfaces (north wall) have been completed and even those partially concealed² have been recovered. All the white plaster on the walls and vault (Fig. 4) has been cleaned and treated.

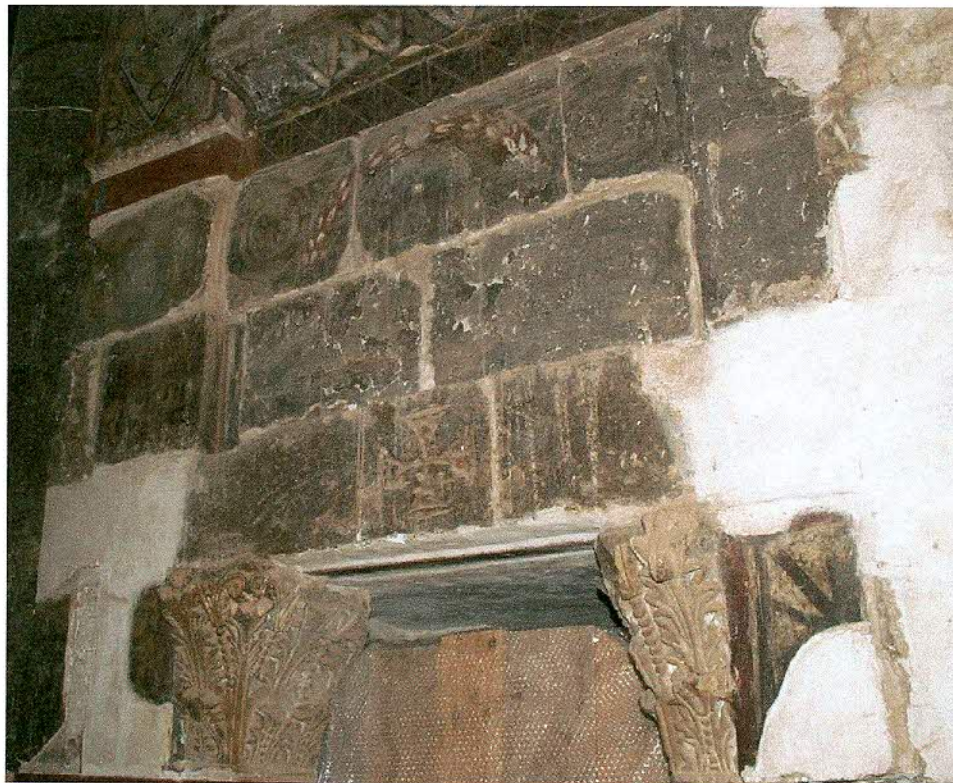
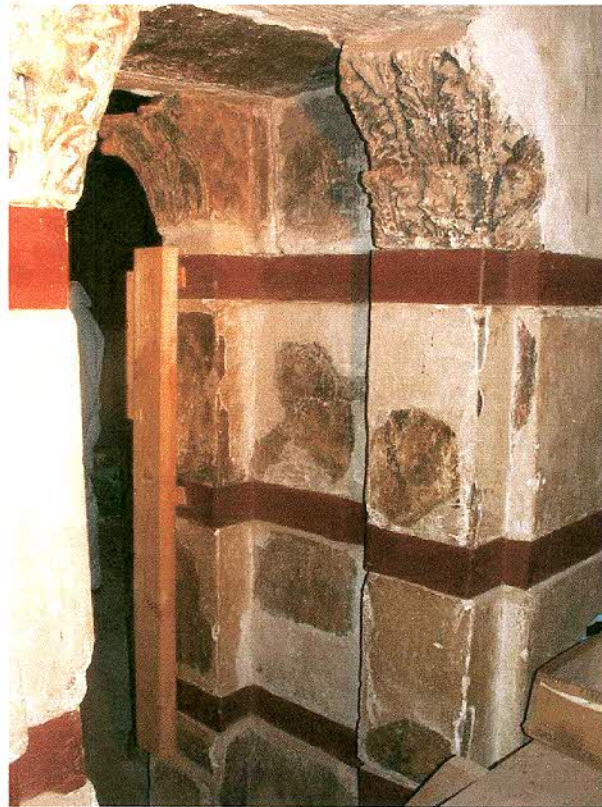
The conservation work carried out in the first tier to the north (Figs. 5 and 6) and south of the arch made it necessary to document the original construction features and various instances of restoration and rebuilding as work progressed.

Repairs to this widespread damage were carried out in the twentieth century by the Comité and subsequently by the Egyptian Antiquities Organization. The repairs effected on the pilasters lateral to the architraves of the north and south doors giving access to the triconch were particularly drastic (see Figs. 5, 6 and 19).

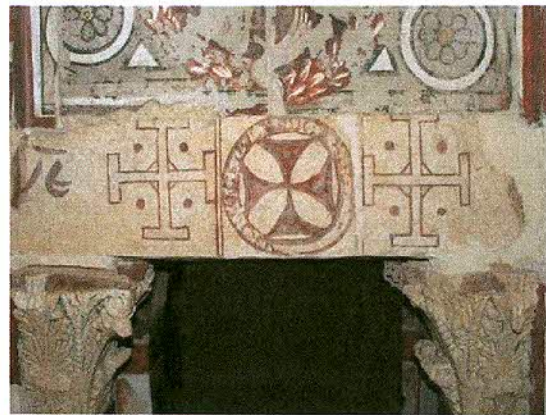
Fig. 8

In the transit areas between the facade and the triconch, both the single-block architraves appear to have been replaced by the Comité. The southern one is decorated with three crosses painted in red⁴, the central one of which is incised as well as painted (Fig. 8).

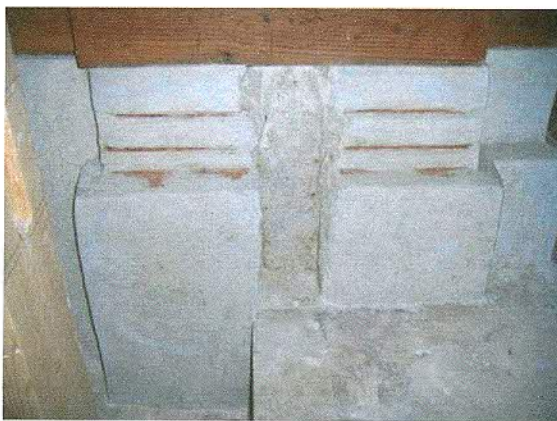
Fig. 9

In the first tier of the facade, the removal of repairs to the plaster has enabled us to make out three vertical lines where the original plaster and the late antique masonry were chiseled away for the insertion of posts for three wooden balustrades, mounted at right angles to the facade. On the north side (Figs. 9 and 10), the post was installed against the pilaster to the left of the access door to the triconch.

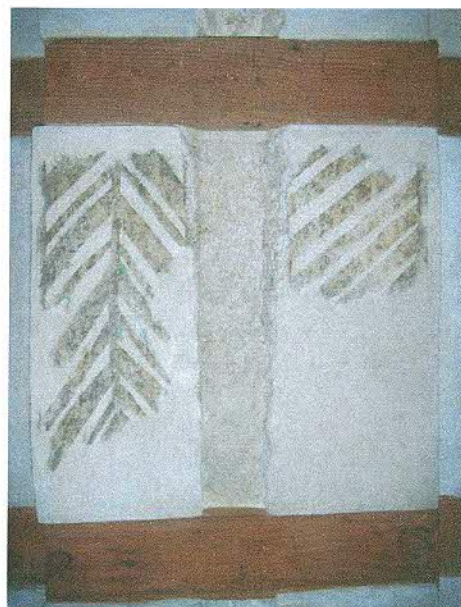
Fig. 10

At the front there is a corresponding break in the plinth of the granite column. On the south side, there are breaks in the pilasters on the left and right of the door leading to the triconch (Figs. 11 and 12).

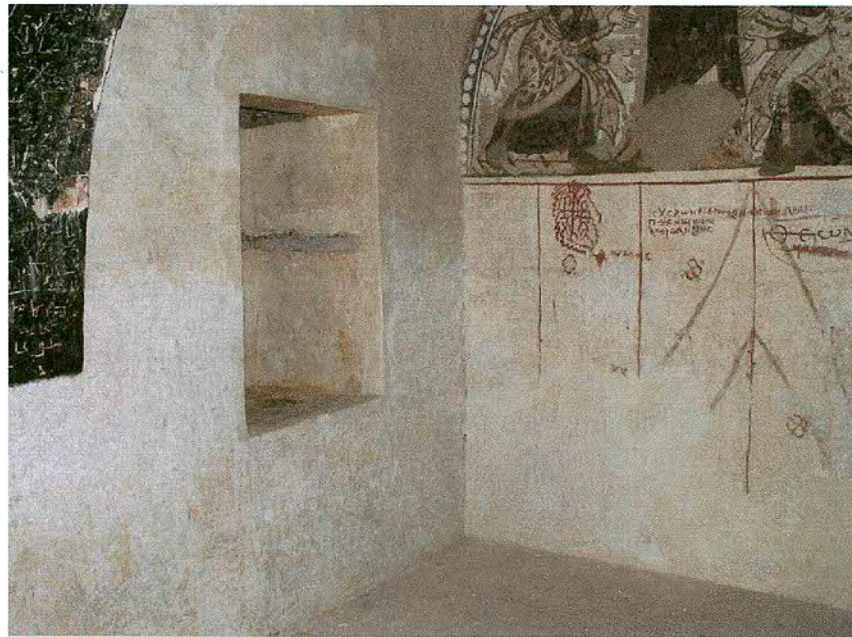
Fig. 13

Work on the plaster in the prothesis (NEC) (Fig. 13) and the adjacent corridor (NEB) has enabled closer study of the characteristics of, and changes made to, the masonry. For a description of this area, please refer to the Autumn 2007 and Spring 2008⁵ mission reports.

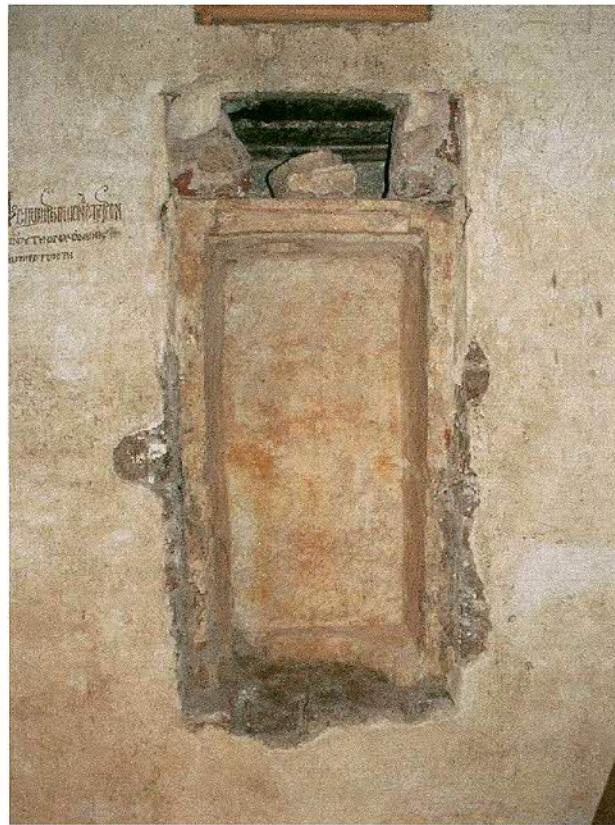
Fig. 14

We can infer from our work in the four niches that they were built at the time of the reconstruction of the external wall, in some cases reusing stone from the late antique building. This is particularly evident in the right-hand niche on the north wall, entirely hollowed out of a single block of limestone (Fig. 14).

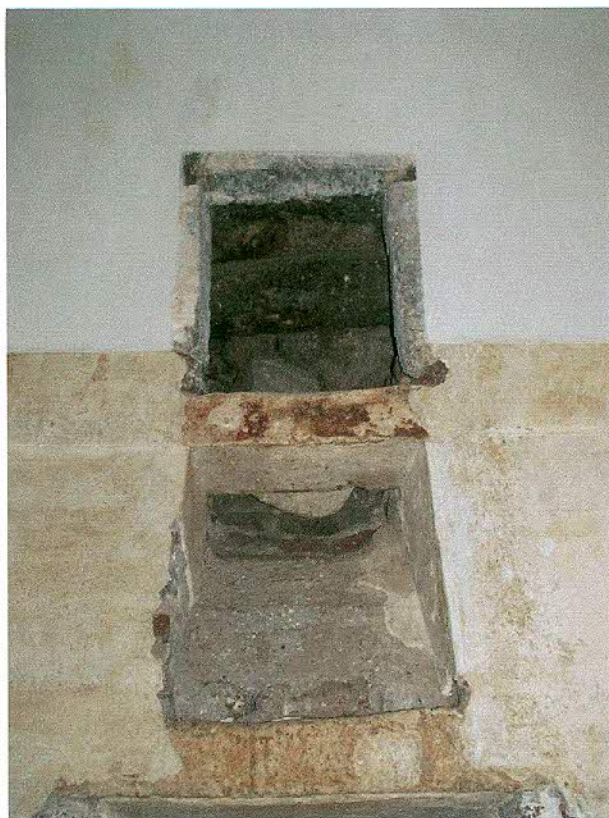
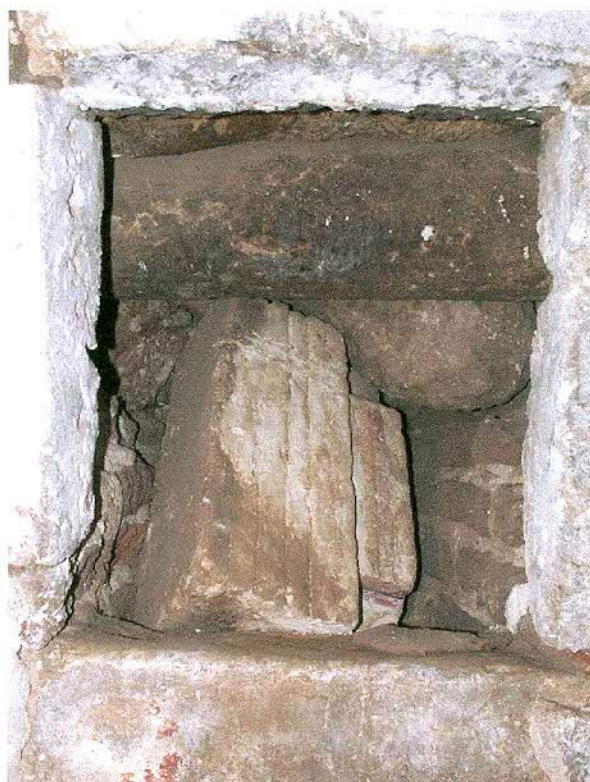
A cavity has been hollowed out of the internal profile of the uprights, possibly to house a wooden door. Two holes on the right-hand upright could represent the housings for the hinges. It is worth pointing out that the stone shows signs of having been worked with a marteline hammer closely resembling that used on the stone blocks of the late antique phase. There is a small recess above the left-hand niche in the same corridor. It appears to have been partially blocked up with unmortared reused pieces of stone probably from the original late antique structure. The shaft of a small column and a section of molding with residual polychrome decoration are clearly visible (Figs.15 and 16).

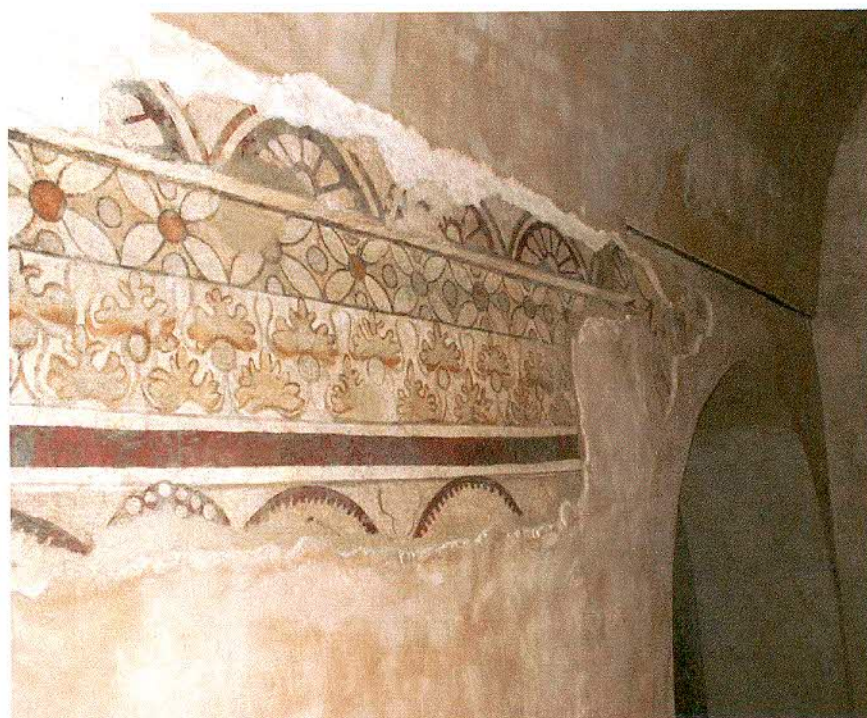
Fig. 17

In the diaconicon and the adjacent corridor (SEC-SEB) (Fig. 17) the repairs to the plaster, probably carried out by the Comité, suggest that extensive restoration and major alterations to the masonry have taken place.

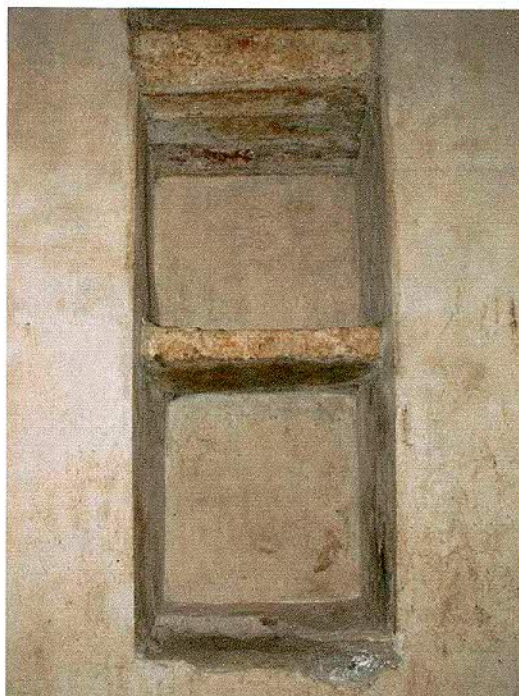
Fig. 18

The niches in the east wall of the corridor (SEB) (Fig. 18) and in the diaconicon (SEC) (not yet examined) appear to date from the time of the reconstruction of the external wall.

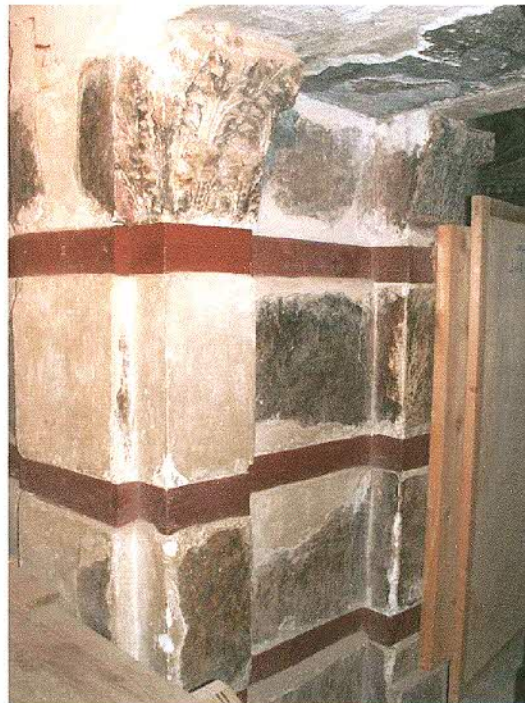
Fig. 19

Before our restoration work began, we observed various repairs made to the plaster under a raking light. We feared that we would only be able to recover small portions of original plaster in a particular band (Fig. 19) that was highly exposed in terms of the religious function of the monument and changes affecting the structure.

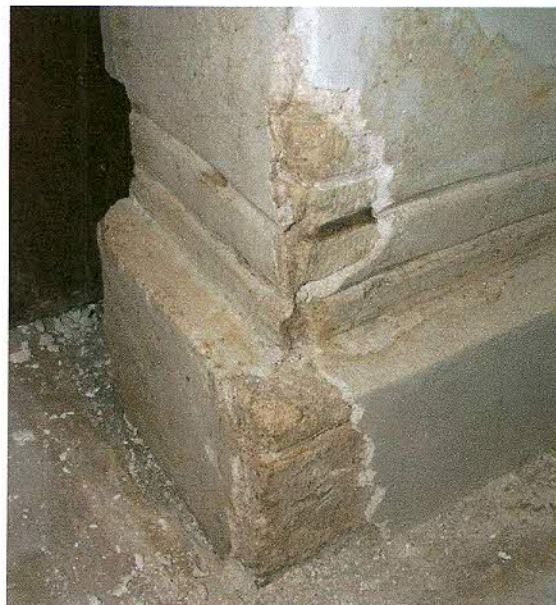
Fig. 20

However, the restoration work has allowed us to recover a considerable amount of plaster that can be attributed to the third phase, both from the flat panels and the molded elements of the plinths of the pilasters and semi-columns (Fig. 20).

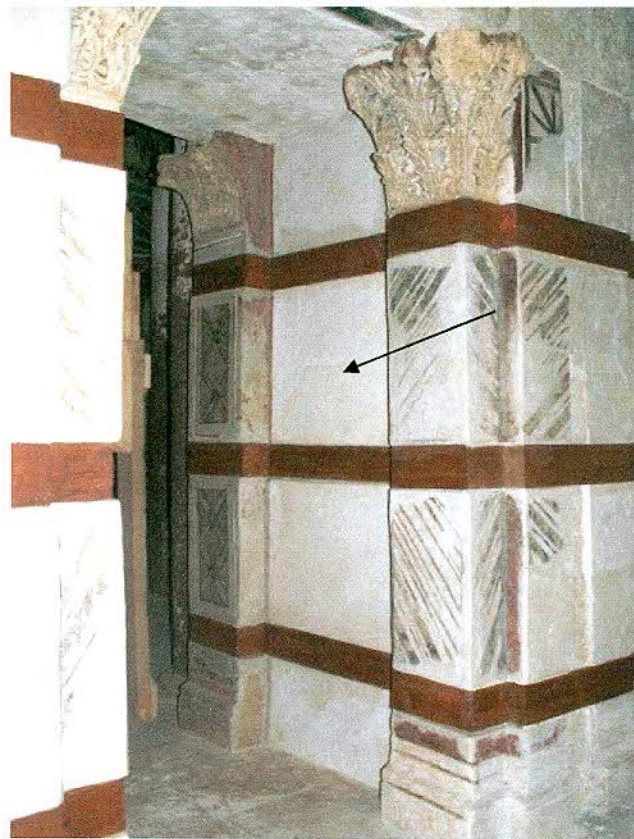
Fig. 24

In the first tier, in addition to extensive portions of third-phase plaster (comparable with the smooth plaster in the first tier of the triconch), there are small fragments of medieval plaster based on lime, sand and straw on the north side of the facade and near the north-east corner in particular. In the transit areas between the facade and the triconch, it has been possible to recover a considerable amount of extant late antique plaster, although it is fairly patchy (Figs. 22 and 23). We have learnt as a result that the side walls of the transit areas were not decorated⁷ (Fig. 24).

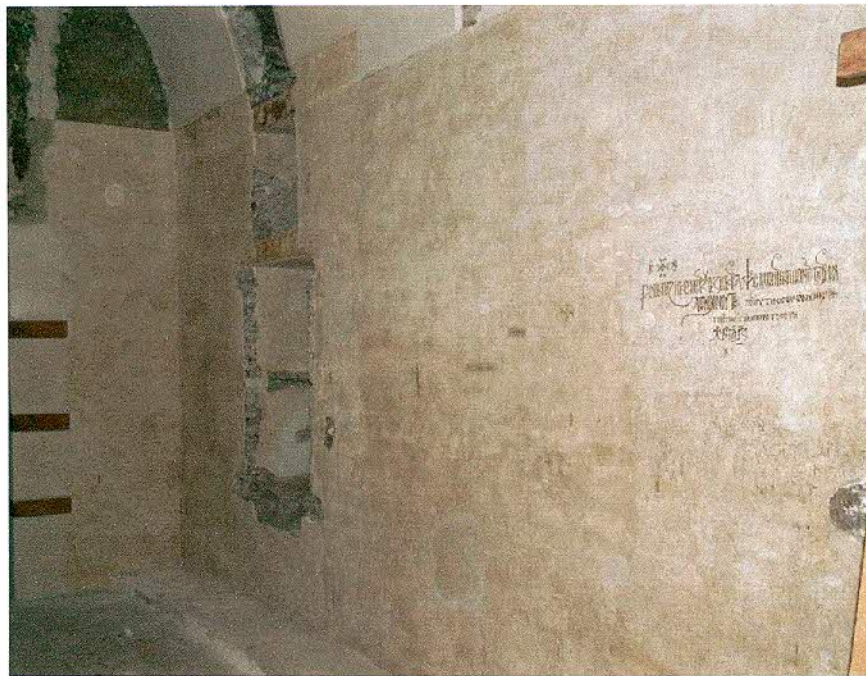
Fig. 25

The medieval plaster layers in the corridor (Fig. 25), the right-hand section of the west lunette and the entire south and east walls, share similar features: an average thickness of approximately 8-10 millimeters; a fine, white, well-blended mortar; a low percentage of sand and a considerable amount of straw in the mix. The surface of this plaster is finished with a slightly irregular white wash¹³.

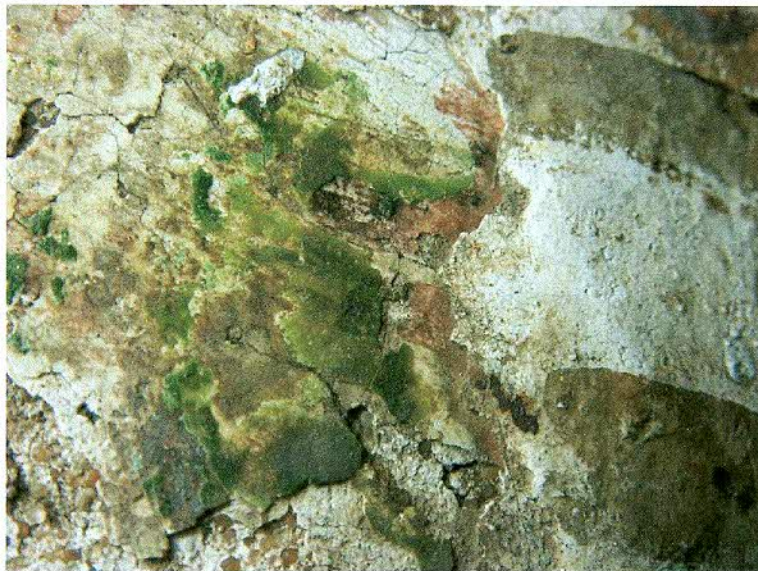
Fig. 26

The plaster on the west wall is similar to that on the south wall. In the south-west corner, part of the red decorative band (inscribing the painted braid) extends over the abovementioned plaster. The entire wall was then finished with one or more coats of lime-based white wash¹¹ (Fig. 26).

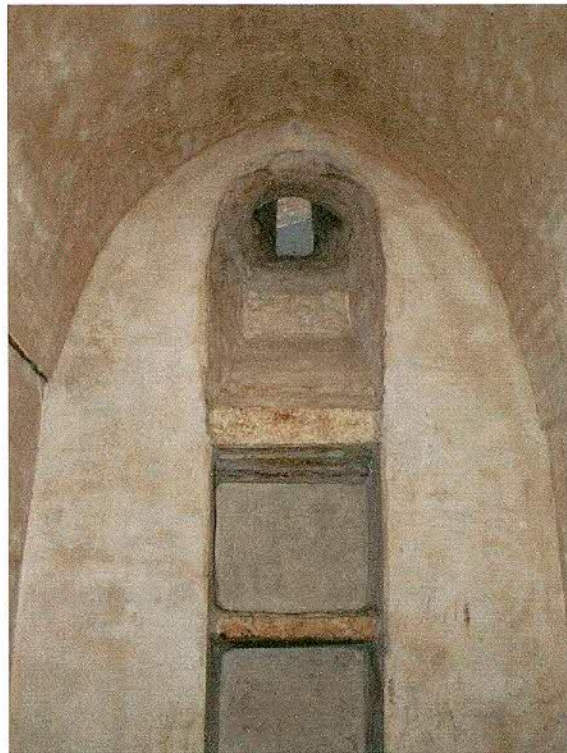
Fig. 27

The plaster in the south corridor appears to have been repaired relatively recently, possibly after the restoration work carried out by the Comité and before the twentieth-century intervention by the Egyptian Antiquities Organization. The mortar used is distinguished by a mix of lime and fine sand that gives the plaster a pinkish-yellow color. The surface of this plaster follows the irregular outline of the masonry structure (Fig. 27).

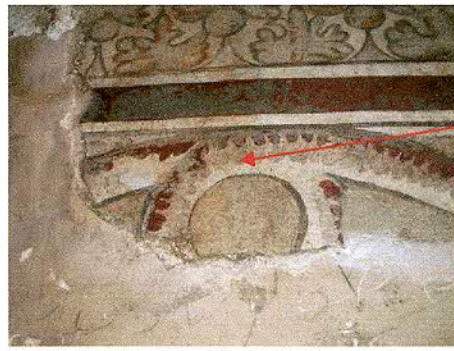
Fig. 28

Fortunately, part of the late antique plaster has survived on the north wall in the form of a band approximately 80 cm wide running below the impost of the vault.

The plaster appears to resemble closely the late antique plaster in the opposite corridor (NEB) (Figs. 28 and 29).

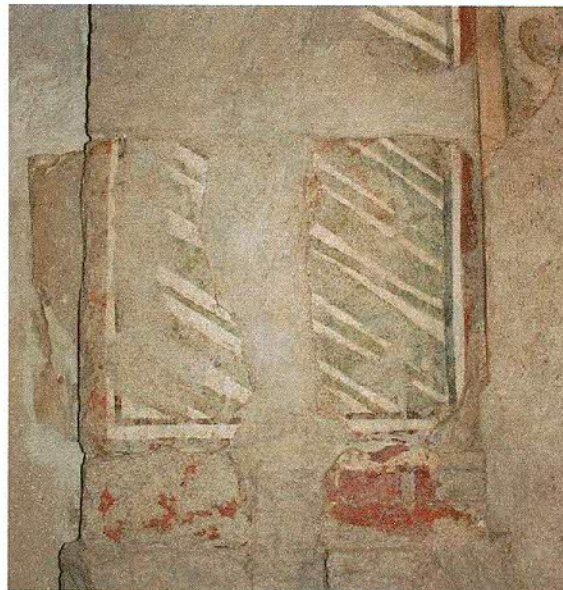
Fig. 33

As already mentioned with regard to the working methods for plaster, we were surprised to be able to recover such a large surface area of third-phase plaster in the first tier. The fragments are extremely limited from the point of view of the paint layer, but suffice to show us that the distinctive decoration of the fake marble panels present in the higher tiers exists in the first tier as well (Figs. 32 and 33).

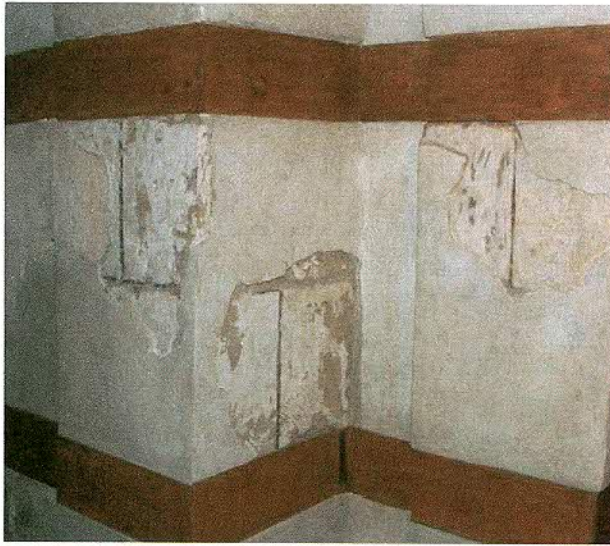
Fig. 34

In the lower part of the north east corner where the third-phase plaster is patchy, we have discovered a typical first-phase decoration under a thin preparatory layer covering the stone (white wash) (Fig. 34). This decoration, that we may consider as being contemporaneous with the checkerboard pattern inside the panels of the stone arch above (Fig. 35), depicts a wall with alternating blocks of stone. The joints are rendered graphically with a thin black line.

At the base of the northernmost pilaster in the facade (F), we decided to restore the plaster only partially in order to leave visible the underlying decoration characteristic of the first phase (see Fig. 34). This decision was reached together with the Project Management.

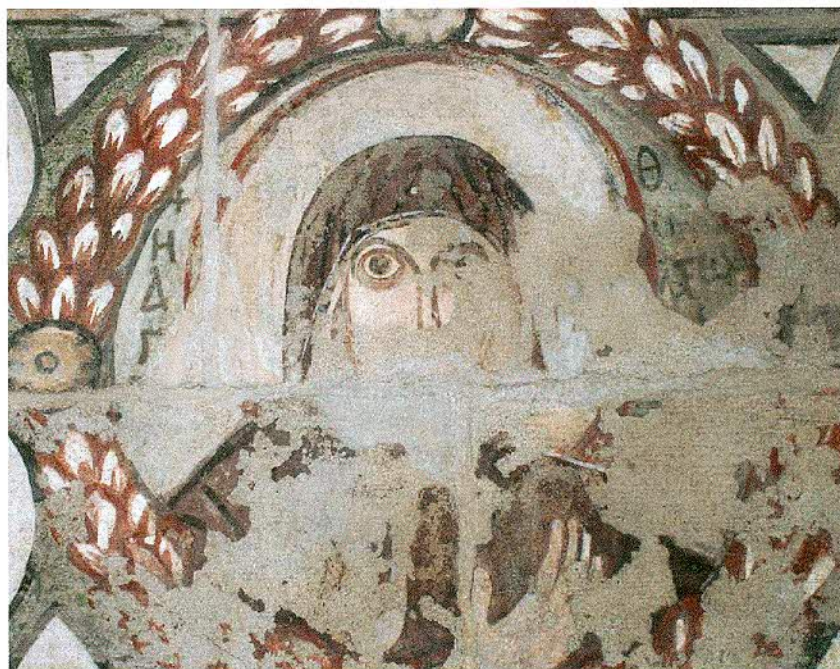
Fig. 36

As on the north side, there is a female image inscribed within a clipeus (Fig. 36) above the south door leading to the triconch.

Upon close inspection, the painting inside the clipeus is comparable to the fourth phase of painting. However, we believe that the painter left the geometric shapes and garland from the encaustic phase (third phase) unchanged and repainted only the central figure.

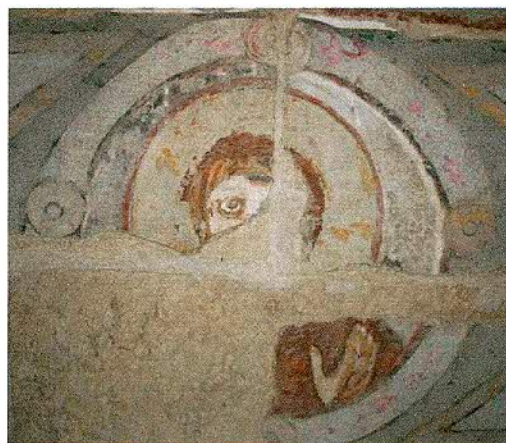
Fig. 37

As already pointed out with regard to the other image inscribed within a clipeus on the north side of the facade (Fig. 37), the figure bears a resemblance to the one over the door in the prothesis (NEC) (Fig. 38). In this case, the resemblance is more marked.

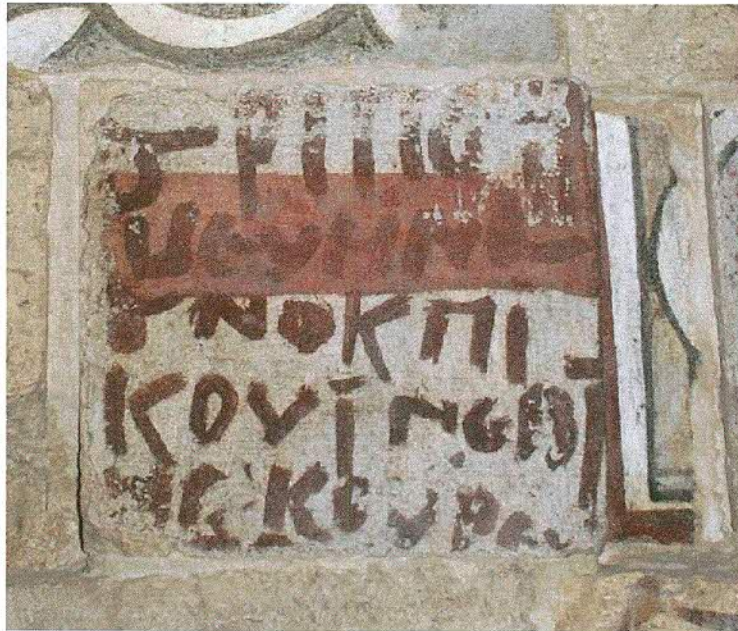
Fig. 39

To the left of the clipeus, a block slightly displaced from its original position bears a Coptic inscription in large red letters (Fig. 39). This is painted on third-phase plaster.

It should be noted that the characteristic red band used by the encaustic method painter to outline his geometric motifs (Figs. 39 and 40) is present in this area.

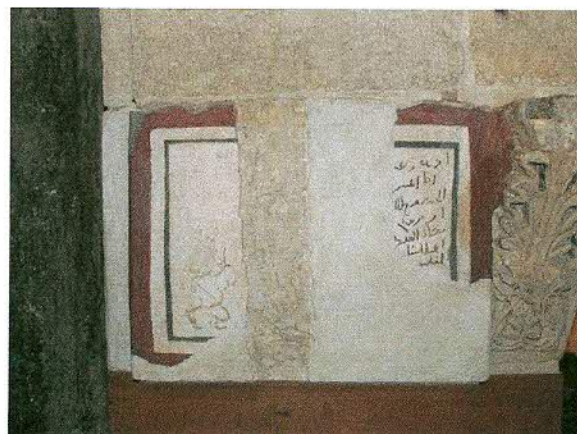
Fig. 40

To the left of the architrave there is part of an Arabic inscription on a fragment of third-phase plaster, now lacking its original coloring (See Fig. 40).

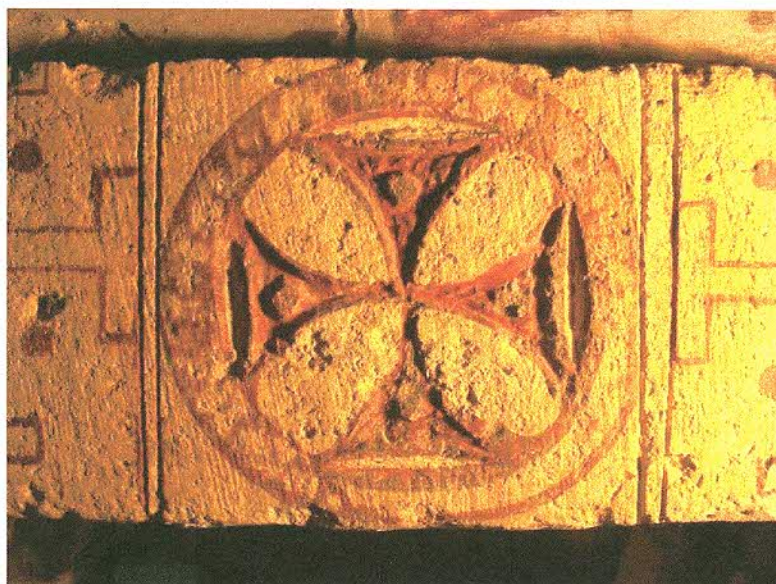
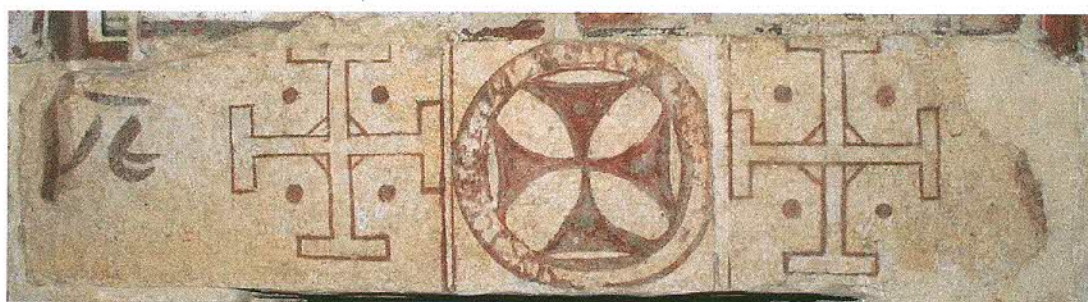
This architrave, replaced¹⁴ by the Comité, bears two painted geometric crosses on the outside and one in the center, incised and inscribed in a circle (Figs. 41 and 42). The central cross, composed of intersecting semi-circular lines, is framed by two parallel vertical lines. The red line and the way the pigment has been applied lead us to associate the execution of the crosses with the abovementioned Coptic inscription.

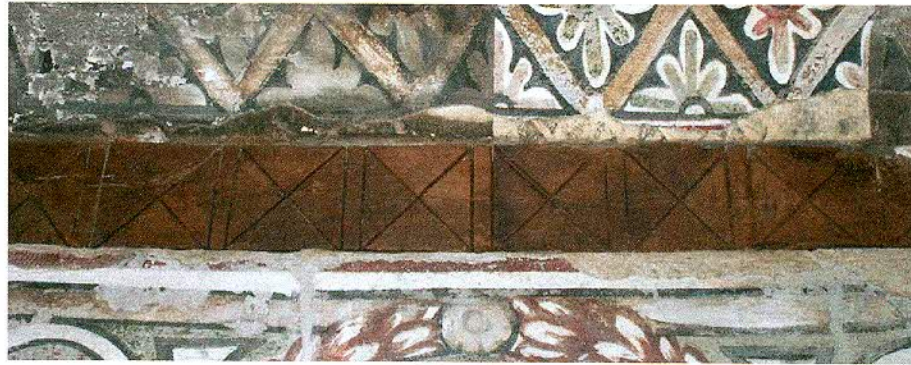
Fig. 43

Slightly above this area there is a wooden element surviving from the medieval¹⁵ period (Fig. 43).

¹⁵ Most of the woodwork was replaced during the restoration work carried out by the Comité. In this instance, an element has survived that although not late antique was probably installed during the medieval restoration. See report: *Microstratigraphic analysis of thin section using spectrophotometer carried out in order to study the plaster, preparatory layers and paint layers. Identification and accurate dating of wood.* Artelab s.r.l. 2008, pages 20-22.

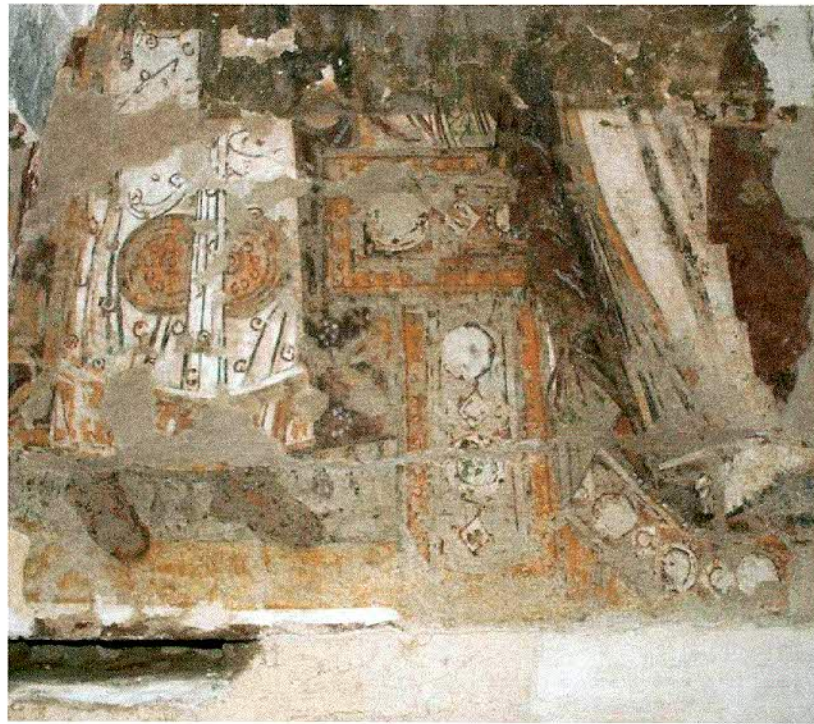
Fig. 44

All conservation and restoration work has been completed in this area with the exception of the vault and the west wall where a large section is undergoing test cleaning (Fig. 44). Upon close inspection, it is possible to discern a certain unity between the decorative elements commonly encountered in Coptic painting from the late antique to the medieval periods in this section.

However, when the state of preservation, the linear style of drawing and the characteristic fineness of the paint layer are observed, one has the impression of being faced with a working method that is different to and more fragile than the other late antique decorations in the church.

Although the test cleaning is of a limited size, the painting appears to depict an enthroned figure, possibly Christ Pantocrator, with a standing figure on the left, most likely an archangel.

During the next campaign work will be carried out on the plaster of the vault. The modern repairs in gypsum will be removed and restoration of this icon will continue, thereby providing an opportunity to study this section in depth and compare it with the other phases of painting in the building.

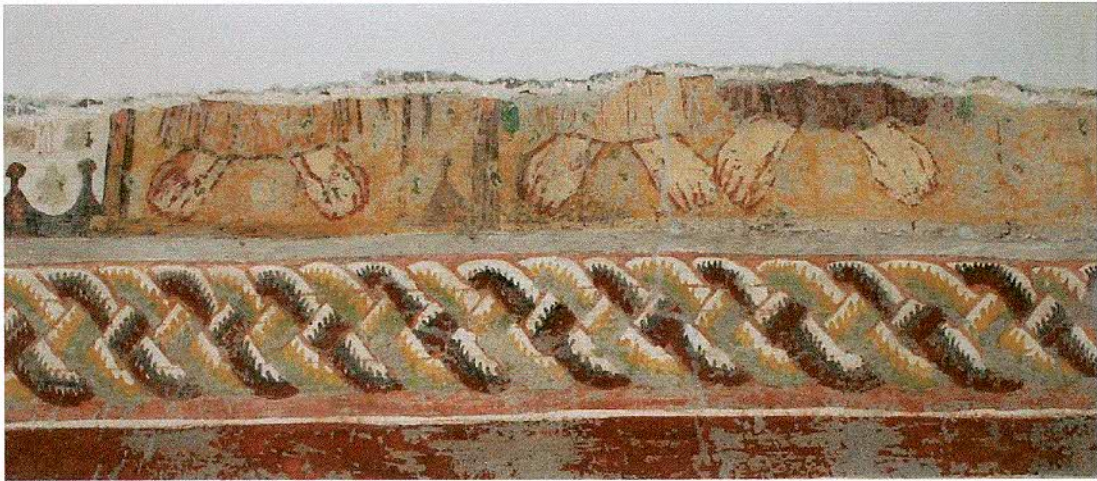
Fig. 47

Near the south-west corner, at the impost of the vault, the removal of the modern gypsum plaster has revealed the lower part of the figures of three saints painted on a portion of plaster that was completely hidden prior to the restoration (Fig. 47).

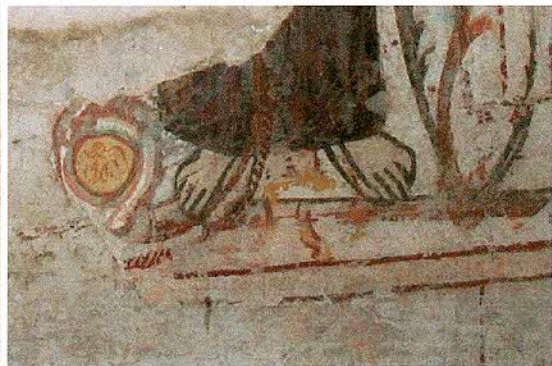
Fig. 49

Whilst acknowledging several technical differences, on the basis of close examination of the subject, we are inclined to associate these fragments with the phase of the *Virgo Lactans* (Fig. 49).

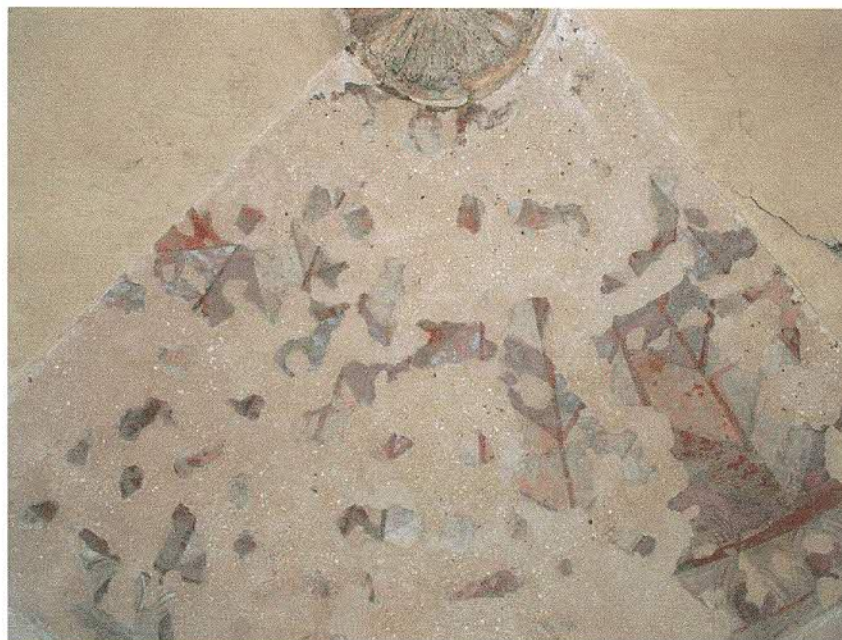
Fig. 52

A classical cornice encloses a large roundel decorated with geometric motifs. The internal space is divided up by radii and concentric rings. The keystone of carved limestone is also the geometric center of the decoration (Fig. 52). In spite of the poor state of preservation, in a limited area it has been possible to observe, under a raking light, that the design was transferred by incision (Fig. 53).

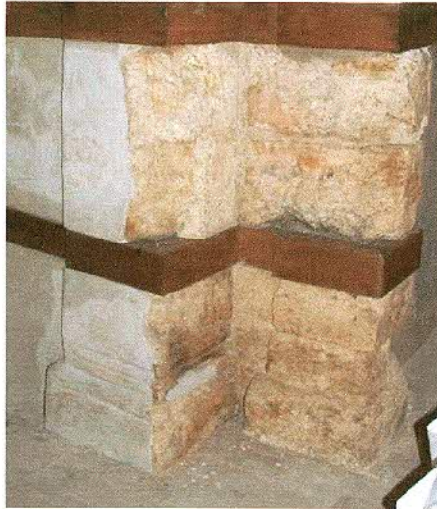
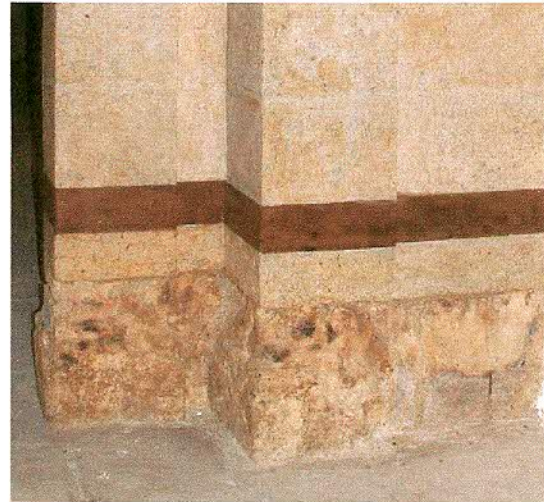
We will limit ourselves here to a description of the state of preservation of the areas involved in the restoration campaign: the first two tiers to the north and south of the access arch to the triconch. The masonry structure in the first tier retains most of the original elements. The blocks flanking the jambs and the moldings of the access doors to the north and south corridors and the triconch are missing. Some of the corbels are broken, with pieces missing. The architraves of the doors giving access to the corridors and the passageways to the triconch appear to have been slightly displaced from their original positions. In the area of the access door to the north corridor, this movement may be connected with the junction between the late antique wall and that altered during the medieval phase (north wall). The impact of the wholesale rebuilding the Comité had to undertake for the entire front of the building can be seen on the side to the extreme south of the facade. Almost the entire stone arch of the access door to the south corridor has been replaced, leaving only a few original blocks in the plinths of the pilasters. The stone of these blocks is unstable and crumbling: large areas of the original surface have been lost and the stone has turned brown, indicating that in the past, there was capillary action by water that was presumably rich in nitrates (Figs.56 and 57). This capillary action is no longer taking place.

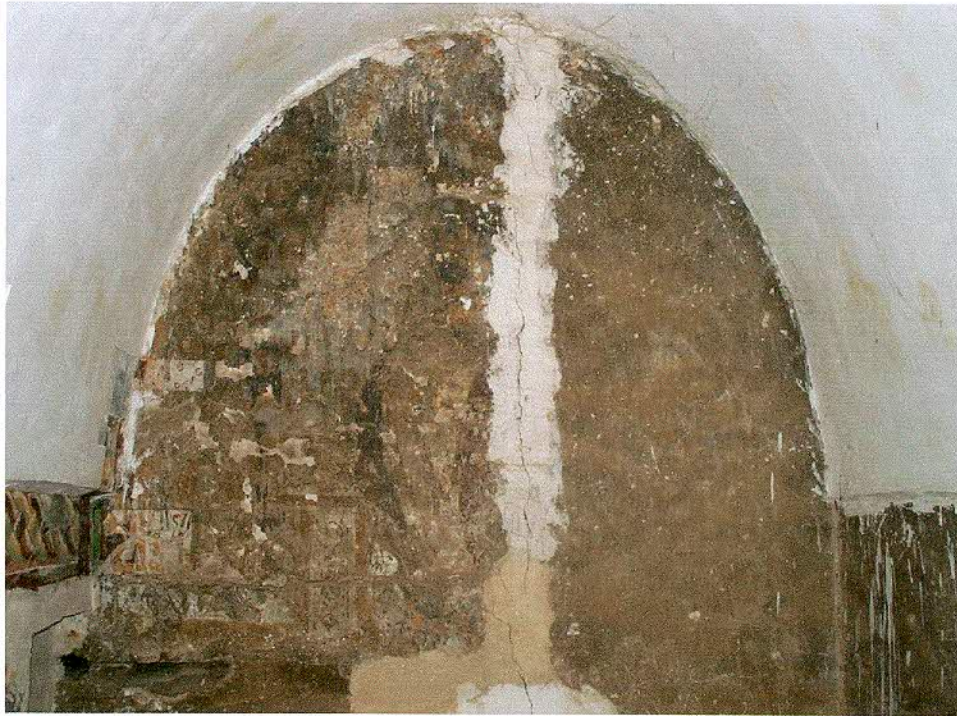
Fig. 58

In the west wall, the state of the plaster does not allow direct inspection of the condition of the masonry. A vertical crack in the center of the wall running from the impost of the vault down to the architrave, repaired during the work of the Comité, suggests that this is the point at which the medieval wall on the right meets the late antique wall on the left (Fig. 58).

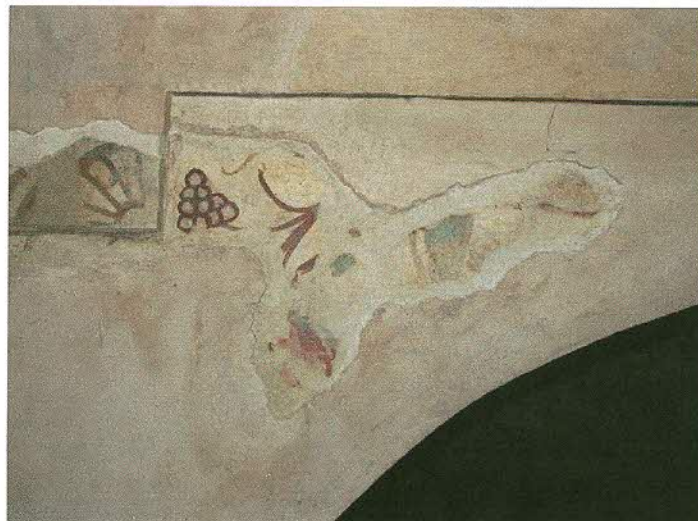
Fig. 59

As already mentioned, the portion of late antique plaster on the north wall occupies only a strip some 80cm wide running along the impost of the vault. Before restoration, the edges of the fragment were partially covered by the layer of modern plaster applied to the entire area. Unfortunately, in the area above the access arch to the diaconicon, there is little original plaster left. What remains is concentrated on the left side of the arch (Fig. 59).

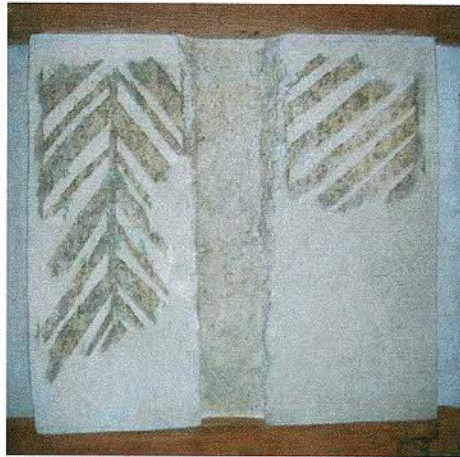
Fig. 60

during services. As a result, on many of the panels, it has only proved possible to recover the outline of the decorative motifs (Figs. 60 and 61).

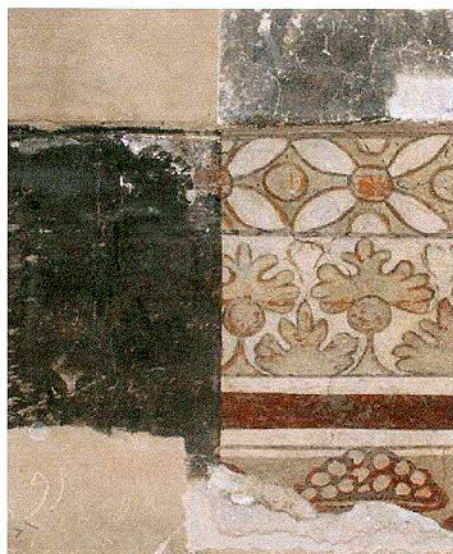
Fig. 62

In the south corridor (SEB) the strip of late antique plaster appears to be entirely obscured by a thick deposit of soot probably caused by the practice of burning oil lamps and candles (Fig. 62). In this area we think that the periodic cleaning operations to which the surface was subjected in antiquity have caused the slight darkening of the surface²⁵.

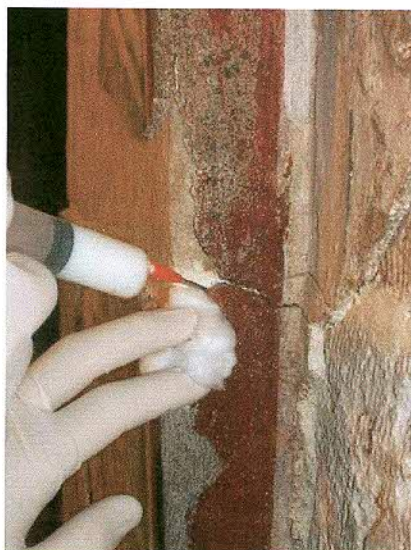
Fig. 65

The first task was to remove dust from the surfaces using soft bristle and sable brushes. Where portions of plaster and fragments and stratified pieces of the paint layer (palimpsest) were in immediate danger of falling, they were secured and consolidated by means of injections of acrylic resin²⁶ into clearly defined areas (Figs. 65 and 66).

This technique was employed in particular on several fragments of painted plaster on the vault of the diaconicon (SEC) and on the south and west walls of the north corridor (NEB).

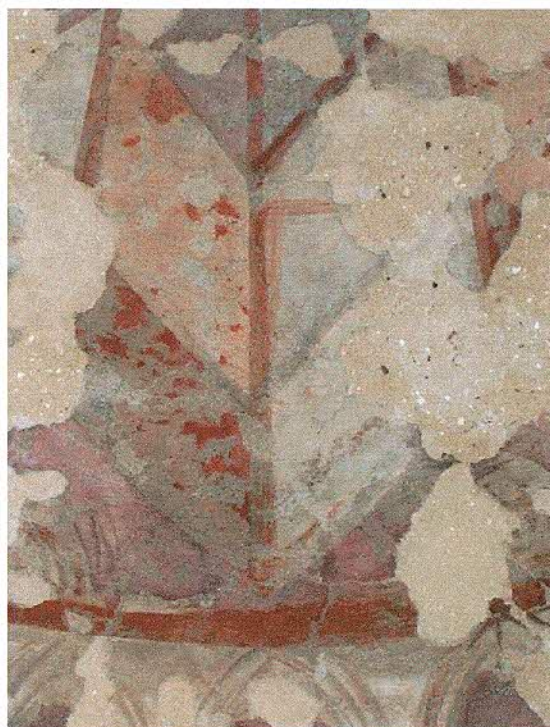
Fig. 67

This technique was employed on the vault of the diaconicon (SEC) in particular. In this case the plaster was taken down to the level of the fragments and presented (Fig. 67).

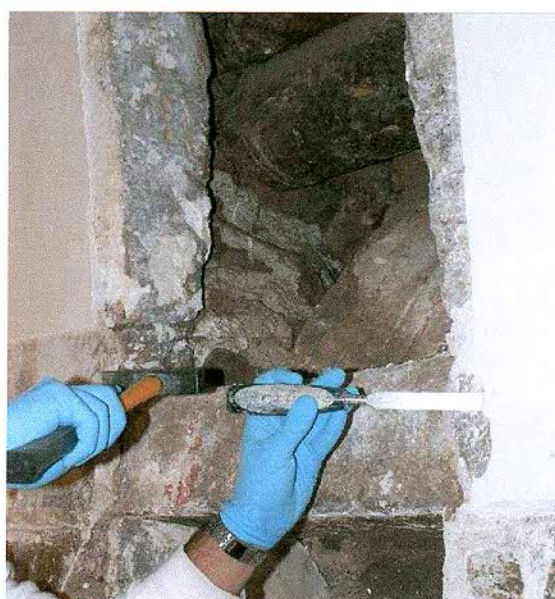
Fig. 68

However, in the case of the paintings discovered in the north and south corridors (NEB and SEB), the plaster was removed from around the fragments and from around the edges of the niches (NEB) (Fig. 68), to give it the appearance of having fallen off naturally.
